# Field Investigation and Laboratory Testing of Exposed Poly(Vinyl Chloride) Roof Systems

Brian J. Whelan<sup>1</sup>, Stanley P. Graveline<sup>1</sup>, Ana H. Delgado<sup>2</sup>, Karen KY Liu<sup>2</sup> and Ralph M. Paroli<sup>2</sup>

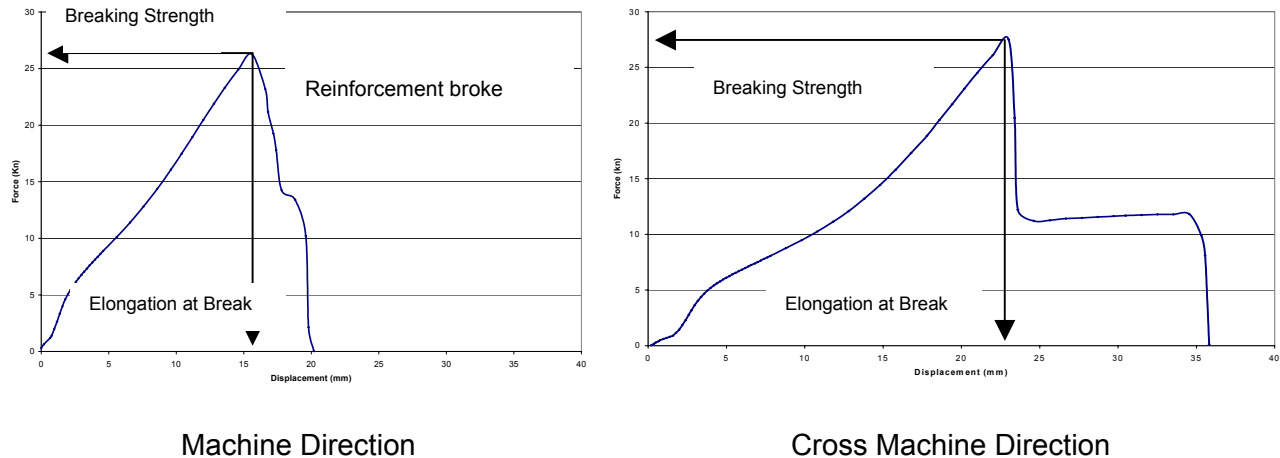
Typical force-displacement curves for the tensile testing of the polyester reinforced roofing membrane are displayed in Figure 1. The load increased with displacement almost linearly at the beginning as the specimen stretched until the reinforcement broke, which caused an abrupt drop in load. No delamination was observed between the polyester fibre and the PVC matrix.

**Figure 1** Typical Force displacement curve for tensile test of polyester reinforced roof membrane (Sample 21C) in the machine (MD) and cross directions (CD)

The tensile properties of the polyester reinforced roofing membrane samples are summarized in Table 4. None of the samples met the minimum breaking strength requirement (35 kN/m) as stated in ASTM D4434 [1] except Samples 13A in the cross direction. The samples retained 70-90% of the minimum breaking strength required for new membranes as specified in ASTM D4434 [1] and over 60% of the samples retained more than 80% of that requirement. However, all samples exceeded the minimum elongation at break value (15%) specified by ASTM D4434 [1]. Note at the time the membrane was made for most of these projects the ASTM Standard did not exist.

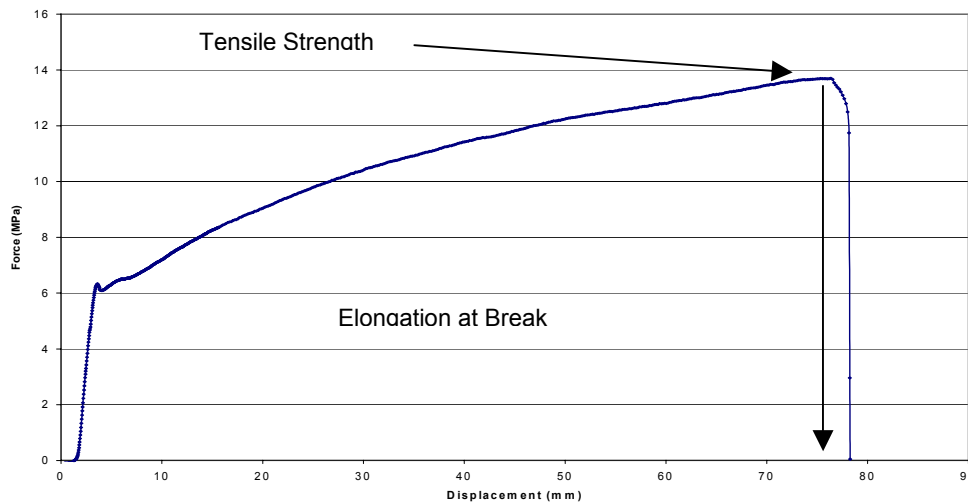
Figure 2 shows a typical force-displacement curve for the tensile testing of the fibreglass reinforced roofing membranes. The load increased linearly with displacement at the beginning. The specimen then started to yield and neck as indicated by the change in slope in the force-displacement curve. It stretched to a high degree (over 100% in general) and finally broke with a snap. No delamination was observed between the fibreglass reinforcement and the PVC matrix.

**Figure 2** Typical Force displacement curve tensile test for fibreglass reinforced roofing membrane Sample 18A).

The tensile properties of the fibreglass reinforced roofing membranes are shown in Table 5. All samples exceeded the minimum requirement (10.4 MPa) but did not meet the minimum elongation at break value (250%) as specified by ASTM D4434 [1]. The elongation at break for the samples ranged from 45-150%, which corresponded to 18-60% of the minimum value specified for new membranes in ASTM D4434 [1]. Samples 4B, 5B, 8A, and 20B had significantly lower elongation at break values (18-40% of ASTM minimum) than the rest (44-60% of ASTM minimum).

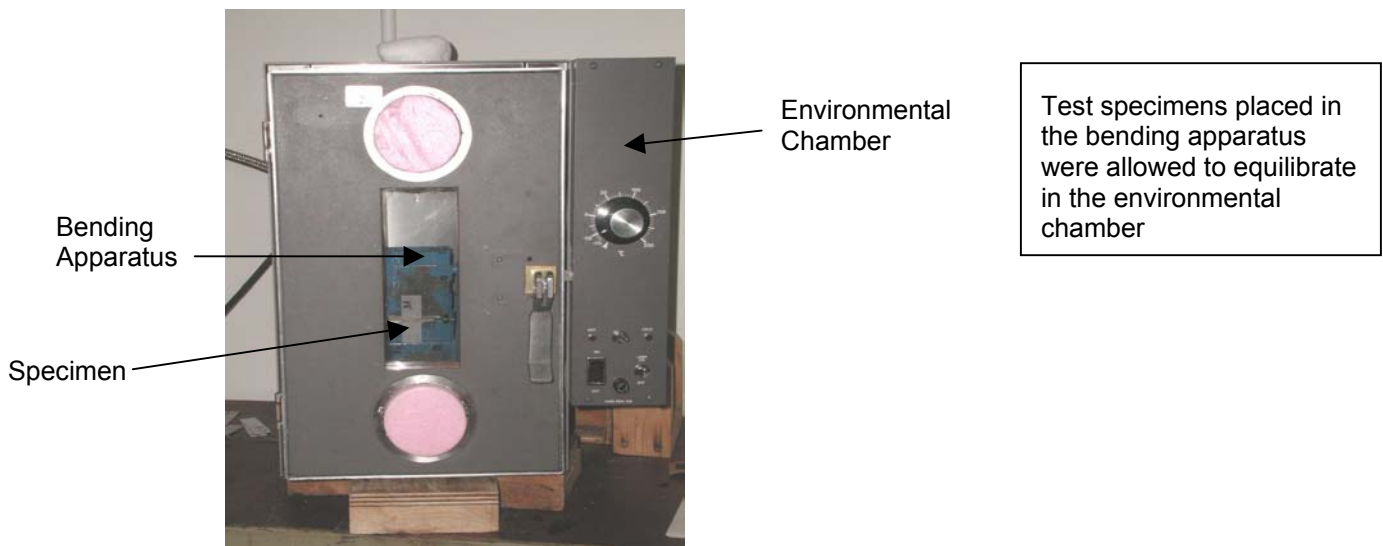
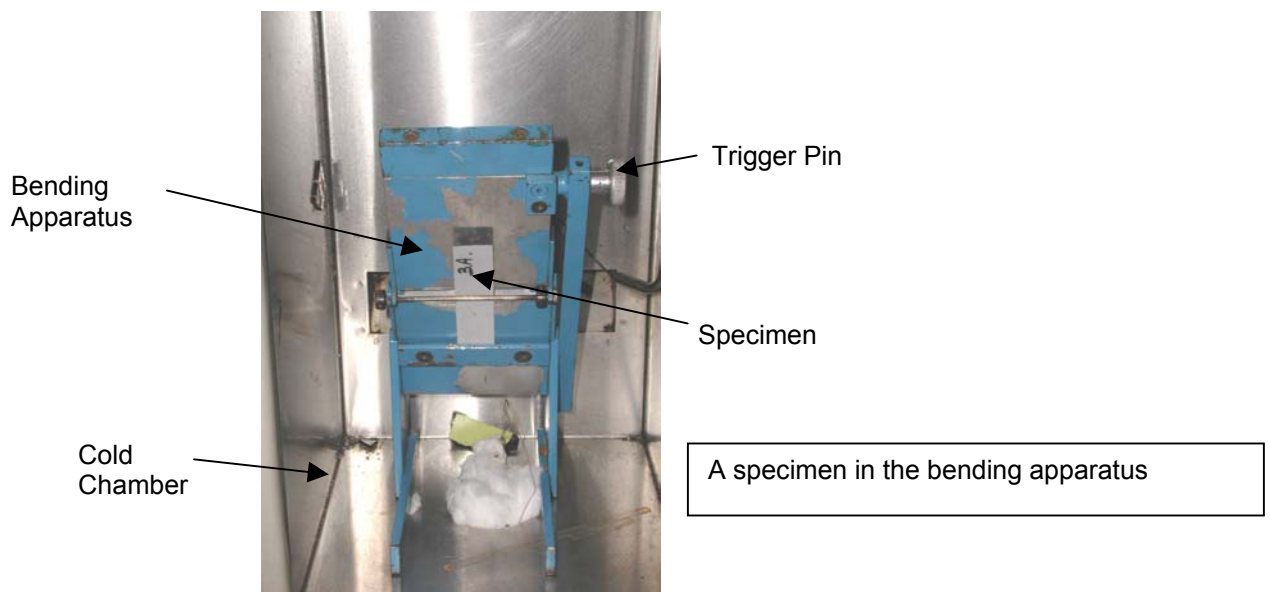
The samples were tested according to ASTM D2136 [7] at -20°C. The specimens were sandwiched between two glass plates in a freezer at -20°C for 4 hours. They were then removed from the glass plates one at a time and placed inside the environmental chamber, which housed the bending apparatus (Figures 1 and 2). The specimens were placed into the bending apparatus and allowed to equilibrate in the chamber for one minute. When the trigger

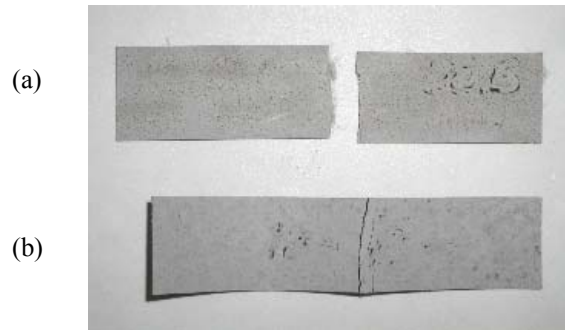
After three specimens had been tested, they were removed from the environmental chamber and examined for surface cracks using a 5X-magnifying glass. During the inspection, each specimen was folded 180° in the same direction as the specimen was bent during the test. If all three specimens showed no cracks in the coating and no fractures, then the sample was considered to have passed. If all three specimens displayed cracks or fracture, the sample failed. However, if only one or two specimens showed cracks, three additional specimens were tested. If any of these exhibited coating cracks or fractures, then the material failed; otherwise, it passed. Typical failed and passed specimens are shown in Figures 3 and 4, respectively.

**Figure 3** Typical failed specimens showing (a) fracture, (b) surface crack

The results of the cold temperature flexibility test conducted at -20°C (-4°F) are shown in Table 6. All samples passed except 13A, 4B, 5B, 7A, 8A, 18A, 20B and 25A.

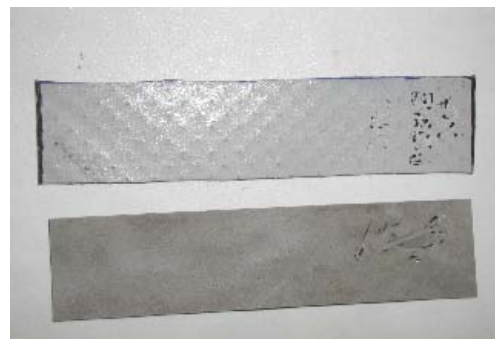
**Figure 4** Typical passed specimens

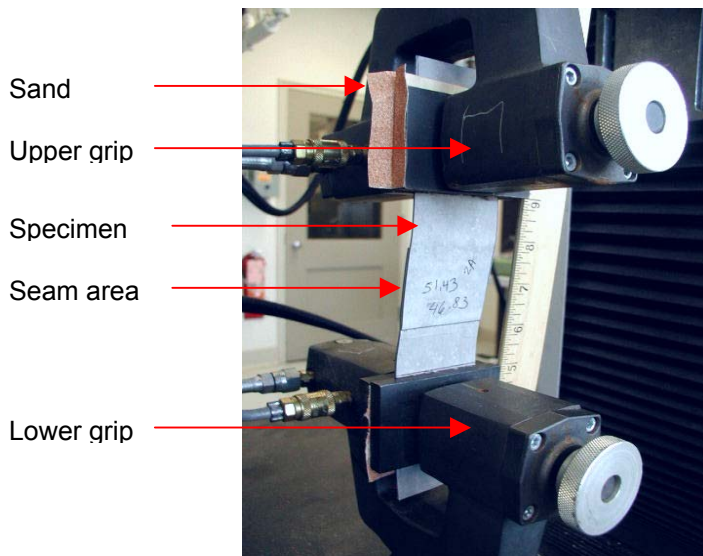
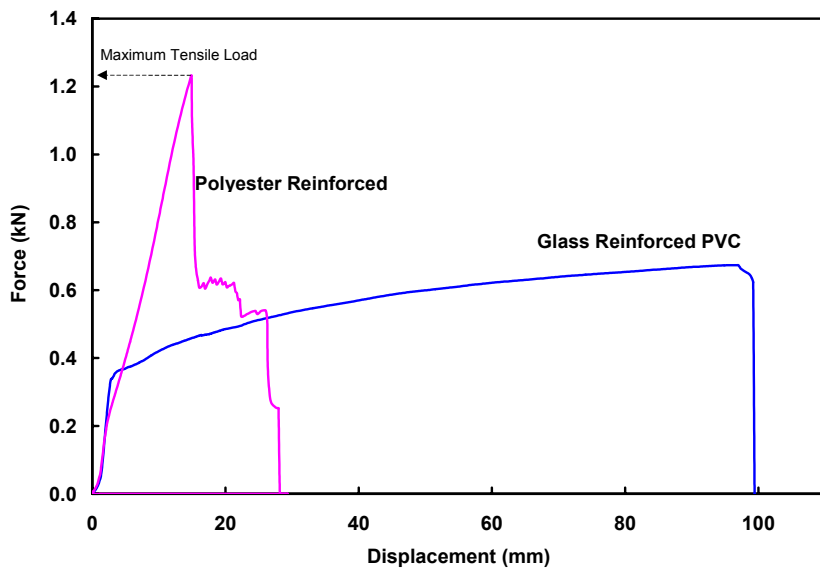
**Figure 5**

Typical force-displacement curves for the seam test of the glass and polyester reinforced roofing membrane samples are displayed in Figure 5. The load increased with displacement as the specimen stretched. The slope of the curve then decreased slightly as the stretched zone started to neck and the surrounding material was drawn into this zone. The membrane stretched further and finally broke, which caused an abrupt drop in load. Both the glass and the polyester reinforced PVC membranes failed in similar manner. However, the glass samples stretched and necked to a higher extent because the random short glass fibres moved more freely with the PVC matrix.

Typical force-displacement curves for the seam test of the reinforced PVC roofing membrane samples.

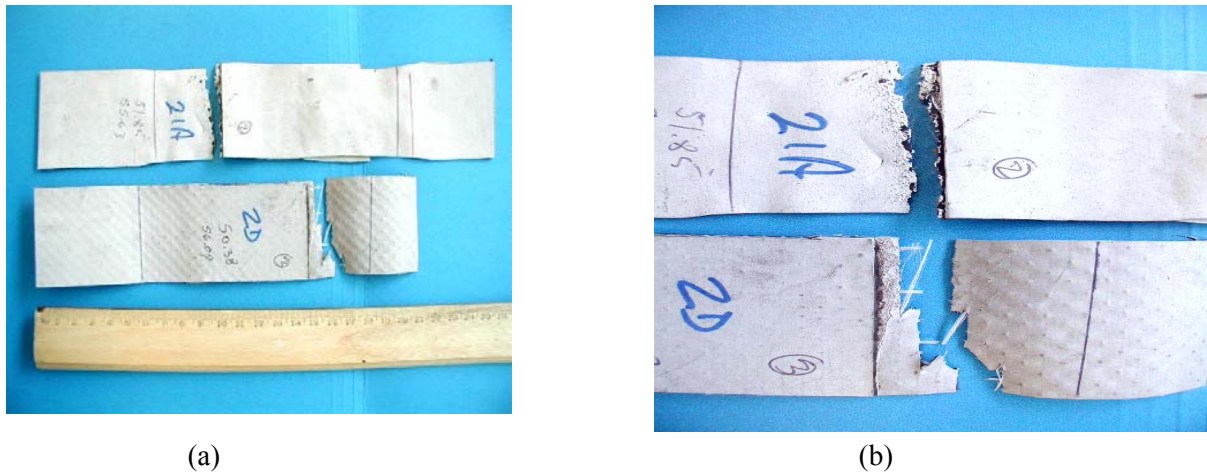
The failure of all specimens occurred in the membrane outside the seam area with the seam remained intact (Figure 6). This indicated that the seam did not deteriorate after the membranes had been in-service for various periods of time and that the seam strength was governed by the tensile strength of the membrane.

Figure 6 Typical failed glass and polyester reinforced seam test specimens (a) failure occurred in the membrane outside the seam area while the seam remained intact (b) close up at area of failure.
